# PROFESSIONAL, HIGHLY ACCURATE MEASUREMENTS OF GEOMETRY AND DEFORMATIONS OF MACHINERY, STRUCTURES AND CONSTRUCTION

**GEOSERVEX**

## KILN ALIGNMENT

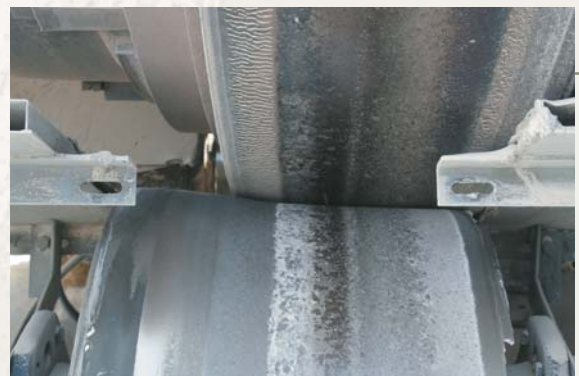
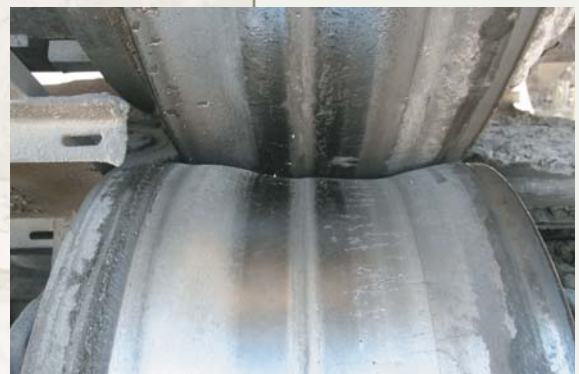
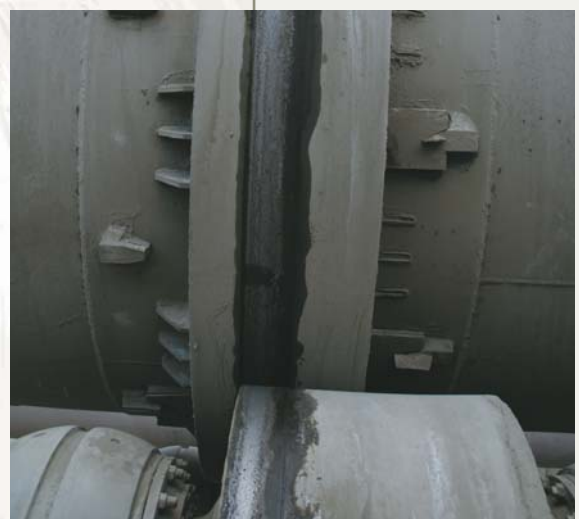
#### Roller's Mechanical Wear

During standard kiln alignment the position of support rollers axis should be determined in relation with the measured kiln axis. Consequently horizontal skewing and vertical inclination of rollers axis is determined. All measurements are taken in the same reference system as kiln axis and the results are related to real (not designed) axis position. Both horizontal as well as vertical skewing have specific impact on axial force generated by the rollers to the tires. Moreover, the forces depend on the rollers' running surface profile. That is why during complex kiln measurement we are studying all parameters and analysing their influence on axial forces generated by the rollers. Simultaneously, we are inspecting rollers' axial mechanical position (contact and gap on thrust collars) and the contact between rollers and tires surfaces. This action is meant to appoint an optimum program of rollers' adjustment.

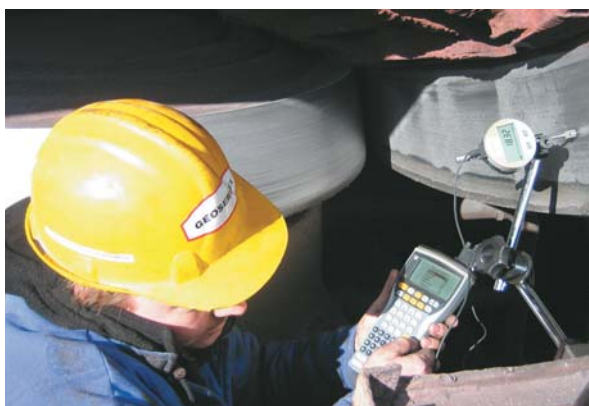
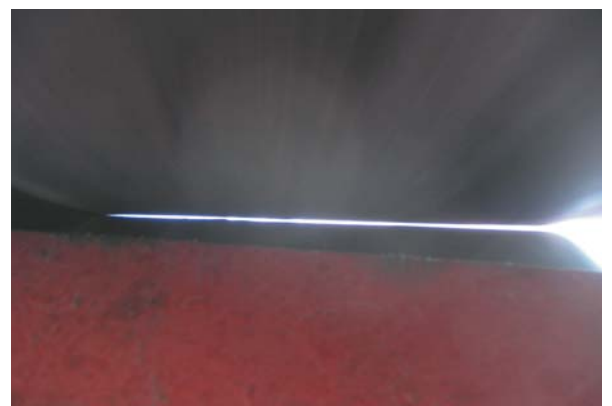
Tires wobbling might be caused by deformation of kiln shell, wear out of shims or inner tire side. The most common case is an effect of the combination of those parameters. Excess axial wobbling has negative consequences on supporting rollers. In extreme cases the wobbling might cause the appearance of a gap between tire and rollers. The gap changes its location following tire movement causing an uneven load on bearings. Furthermore, the contact of the tire with the roller has a limited surface what causes a drastic increase of Hertz pressure. Tire wobbling might be eliminated by proper repair actions but background problem should be diagnosed first of all. During kiln inspection, we are making an exact measurement of kiln shell deformation and examine correlation between a tire wobbling and shell run-out. In order to precisely visualize the appearance (or its lack) of correlation of those factors we are making three-dimensional modelling of really measured values. By rotating the model with scaled deformations we may reveal changes and point their causes. The tool helps to undertake decisions concerning the replacement of shims, replacement or adjustment of kiln shell or machine of inner tire side.

Girth gear wobbling is diagnosed and visualized in the same way. In the case, after the cause fixing, wobbling reduction might be achieved by the gear centring in relation to rotation axis.

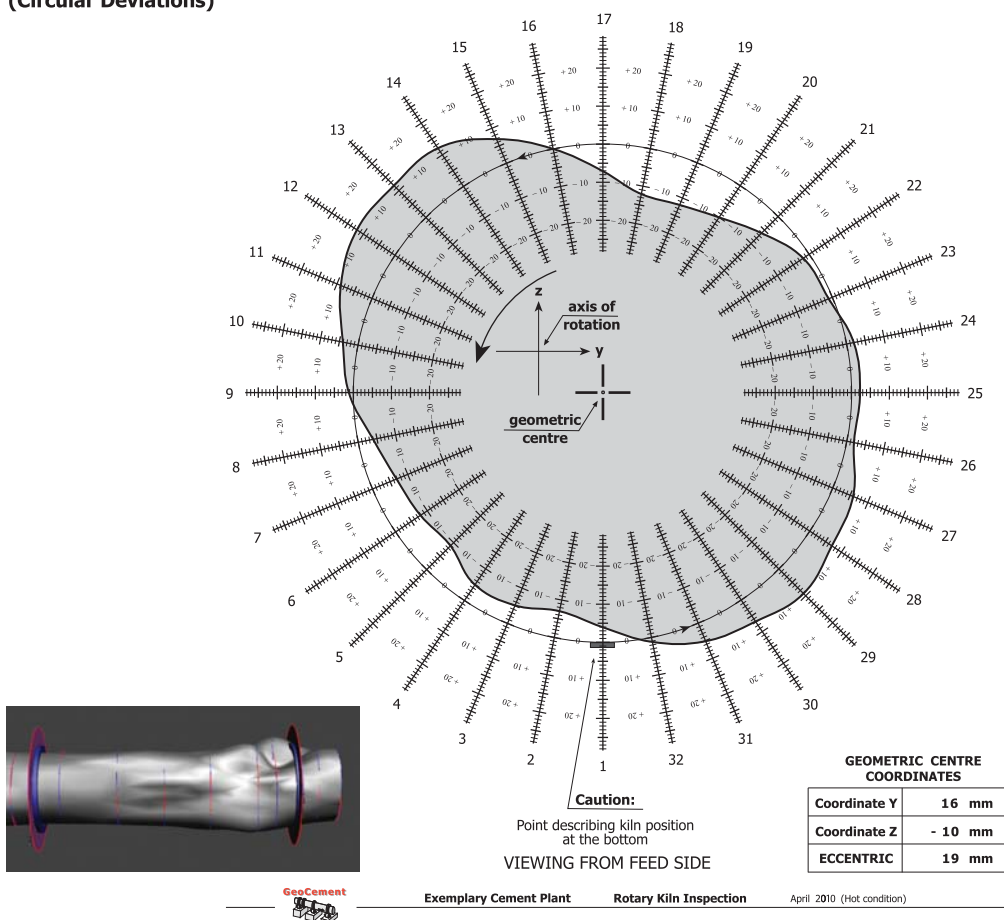
**CROSS SECTION No 21**  
Deformation Scale - 1 : 1

**Radial Diagram of Shell Deformation  
(Circular Deviations)**

Measurements of kiln shell geometry with the use of linear laser scanning made it possible to precisely visualize shell deformation. Former solutions did not make it possible for the monitoring of relations between shell circularity deformation, shell radial run-out, tires and gear wobbling and gear radial run-out. We have decided to work out a way to make a three-dimensional model of all parameters at once. In effect, the model appeared to be the most advanced in the World method of kiln shell deformation visualization related with the visualization of axial and radial movement of tires and gear. We allowed our customers to analyse the condition of shell geometry and its correlation with tires and gear wobbling on their own computer screen. Our model rotates the same way as the real kiln, it might be easily turned every side and even enables the customer looking inside the kiln shell. But the most important advantage of the solution is possibility of the kiln shell condition assessment, planning of necessary repairs and replacements, determining of correction cuts placement and its influence on tires and gear wobbling.

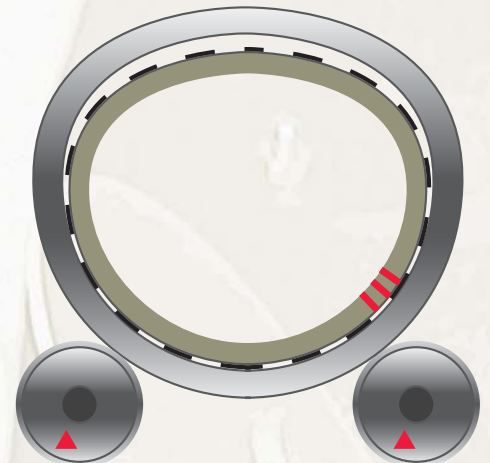
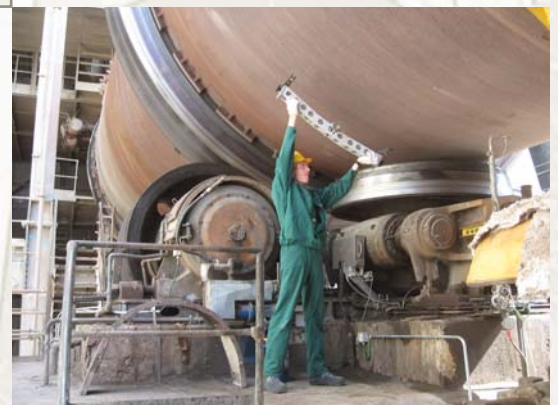
## ► TIRE MIGRATION & SHELL OVALITY TEST

Rotating kiln shell is also subject to plastic deformations defined as ovality. Measurements of this parameter are done with the use of the SHELLTEST device. Shell ovality is correlated with alignment and supports load distribution, but in our methodology we are not making the use of ovality measurement results to set an optimum kiln axis location. The shelltest is made only to examine how plastic is the shell in its support zone and what impact it has on the condition of kiln refractory lining. Furthermore, the measurement may help to indicate shell crack within the measured cross-section. The ovality measurement is hard to precisely interpret as the maximum of the parameter appears under the tires while the measurement is taken far away from the maximum (due to the presence of thrust rollers and heat protection covers). That is why we are considering this measurement as optional. The ovality is strongly correlated with circumferential tire migration and during standard alignment it is sufficient to evaluate this parameter.

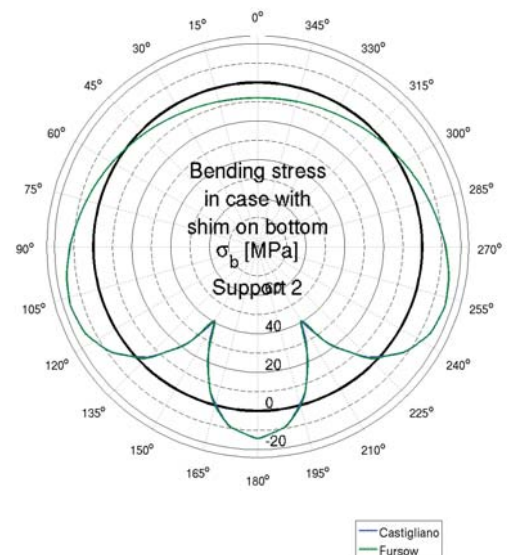
## ► LOADS, PRESSURES, STRESSES

Our long experience and mechanical analysis of many types of kilns produced by all reputed kiln manufacturers let us state that a correctly designed rotary kiln should have a straight geometric axis being in accordance with rotation axis. However, in some cases the straight kiln axis may not be optimal for the kiln operation. Simple human errors, the application of wrong principles during modelling, finally, the increase of production parameters such as capacity increase, fuel change, raw-material composition change, all that may have an impact on the change of supports load.

In effect, the kiln aligned for straight line might not meet key mechanical parameters, such as longitudinal bending stress of shell, pressure on bearings, Hertz pressures on contact between rollers and tires, shear stress etc. Recently, we have observed growing demand for such analysis due to a global tendency to strive after the maximum production effectiveness.

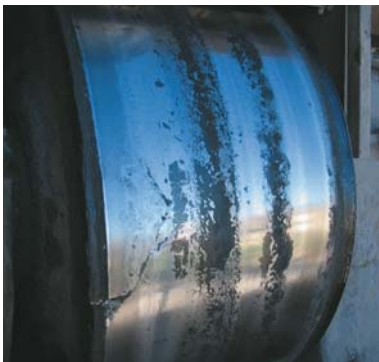
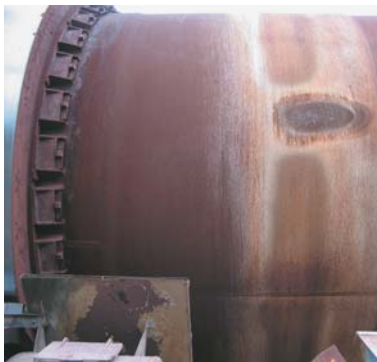
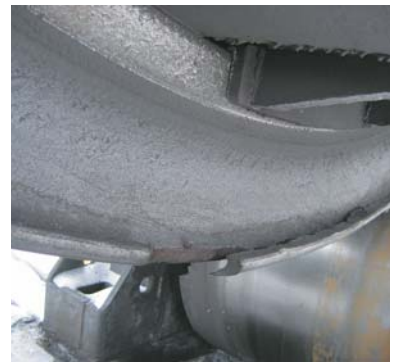
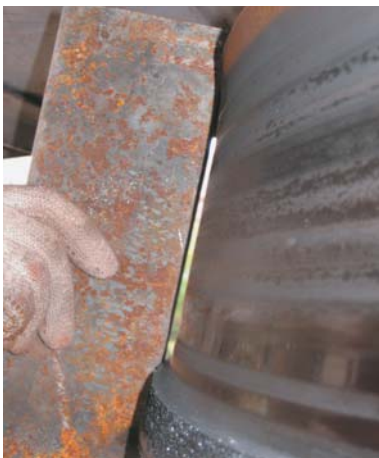
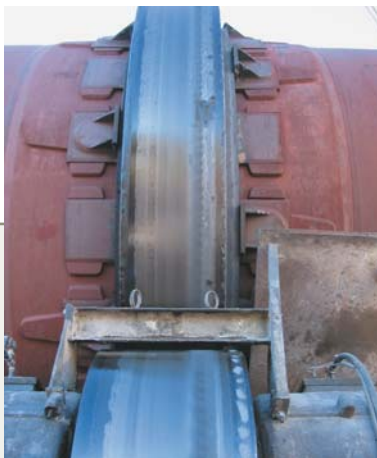
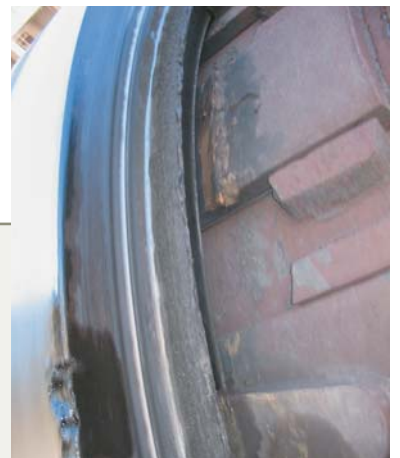
## ► OVERALL INSPECTION

Rendering the service of alignment as a standard we perform visual inspection of kiln components. We examine the condition of rollers, tires, shims and retaining rings and stop-blocks, rollers shafts, sealing as well as the condition of kiln shell for any visible symptoms of overheating or cracks. We control in details the condition of the girth gear and pinion, gear fastening system, completeness of bolts and condition of welds. Additionally, we pay attention to condition of frames, foundations, adjustment systems and general maintenance of kiln surroundings. Based on the inspection, we make a photographic documentation showing concerning problems, irregularities and repair recommendations.

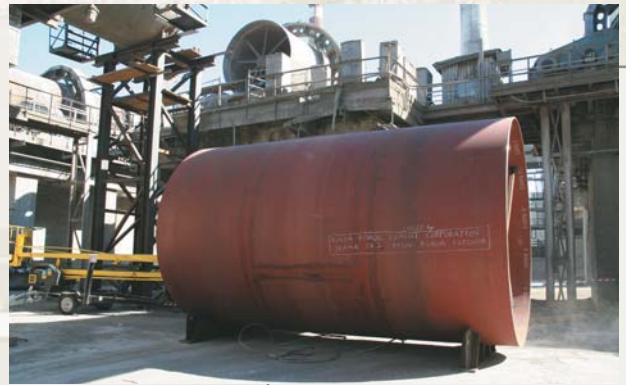
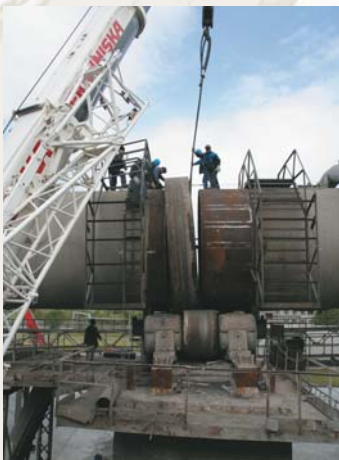
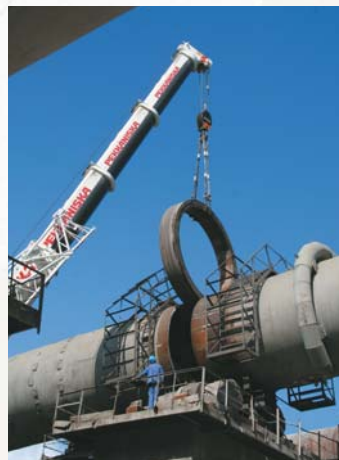
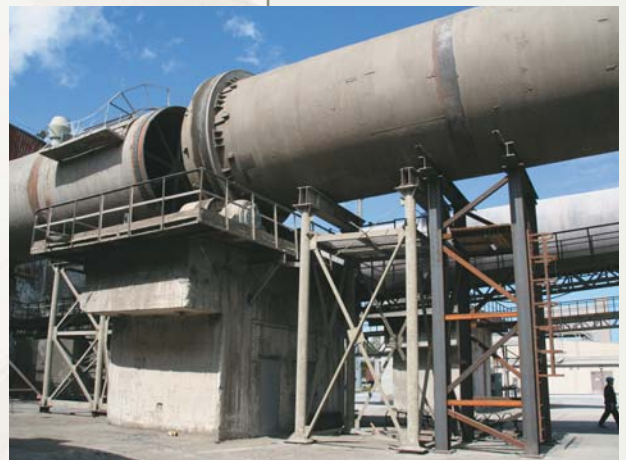
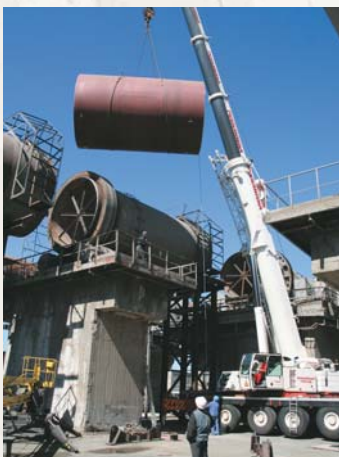
Our activity also covers geometrical supervision over the assembly of new production lines, modernisation and overhauls, replacement of shell sections, shell straightening, elimination of mechanical crank through correction cuts as well as supervision over replacement of rollers and tires. We have supervised new kiln installations, complicated shell overhauls, joining shell sections replacement with correction cuts in order to correct old segments. We have got enormous experience in "reclaiming" kilns that were not working for years and in making them operation ready.

We offer complex examination of the whole cement plant and buildings settlement and dislocation. The service has been used as a tool to monitor safety installation and in particular, when there are visible threat symptoms (building wall foundation cracks, deviation of high-rise buildings and structures etc.)
